Retrieval analysis of alumina ceramic-on-ceramic bearing couples

Muhammad Korim¹, Susan Scholes², Anthony Unsworth³, and Richard Power¹

Background and purpose — Ceramic-on-ceramic (CoC) bearings have been in use in total hip replacement (THR) for more than 40 years, with excellent long-term survivorship. Although there have been several simulator studies describing the performance of these joints, there have only been a few retrieval analyses. The aim of this study was to investigate the wear patterns, the surface properties, and friction and lubrication regimes of explanted first-generation alumina bearings.

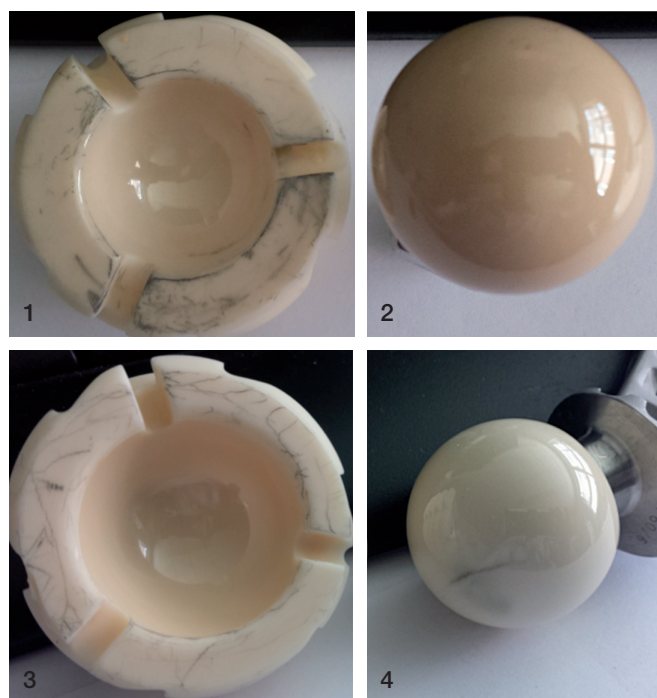
Figure 1. Typical bearings illustrating minimal wear at the cup periphery (1), minimal wear on the femoral head (2), minimal wear at the center of the cup and rim wear peripherally (3), and stripe wear on the femoral head (4).

are no accepted ways of describing wear patterns on retrieved bearings. We described the wear as being predominantly central or peripheral (Figure 1).

After a mean of 16 years in vivo, only 33% (3/9) of the femoral heads showed evidence of stripe wear and 2 of 3 of the matching acetabular cups showed rim wear, suggesting that edge loading may have been a mechanism of stripe wear. The other bearings showed minimal wear, with areas of darkening and roughening only.

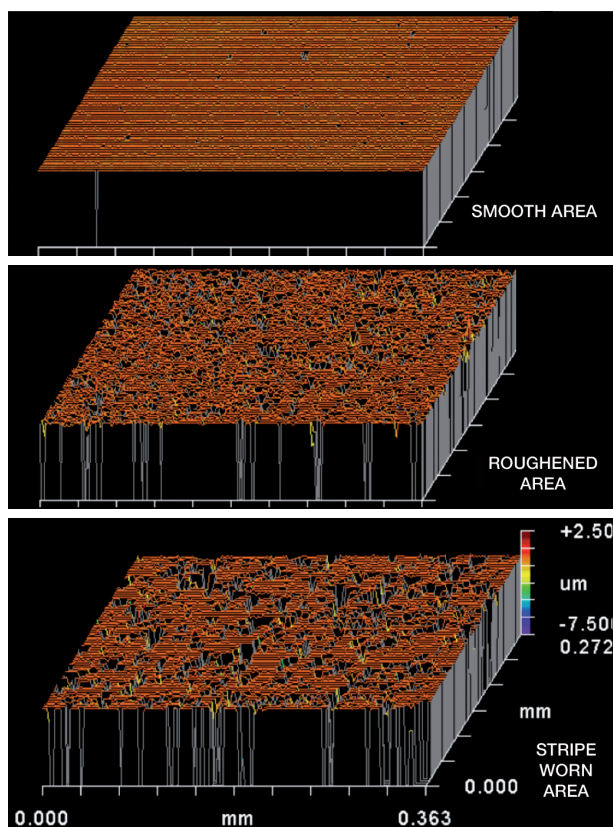
Surface topography of the femoral heads and acetabular cups showed that the unworn areas had a very smooth surface, but the roughened and areas with stripe wear had more peaks and troughs, as shown in Figure 2.

Figure 2. Surface topography of femoral head on smooth (top panel), roughened (middle panel), and stripe-worn areas (bottom panel). The graphs have the same scales on the x- and y-axis as the graph at the bottom with stripe wear.

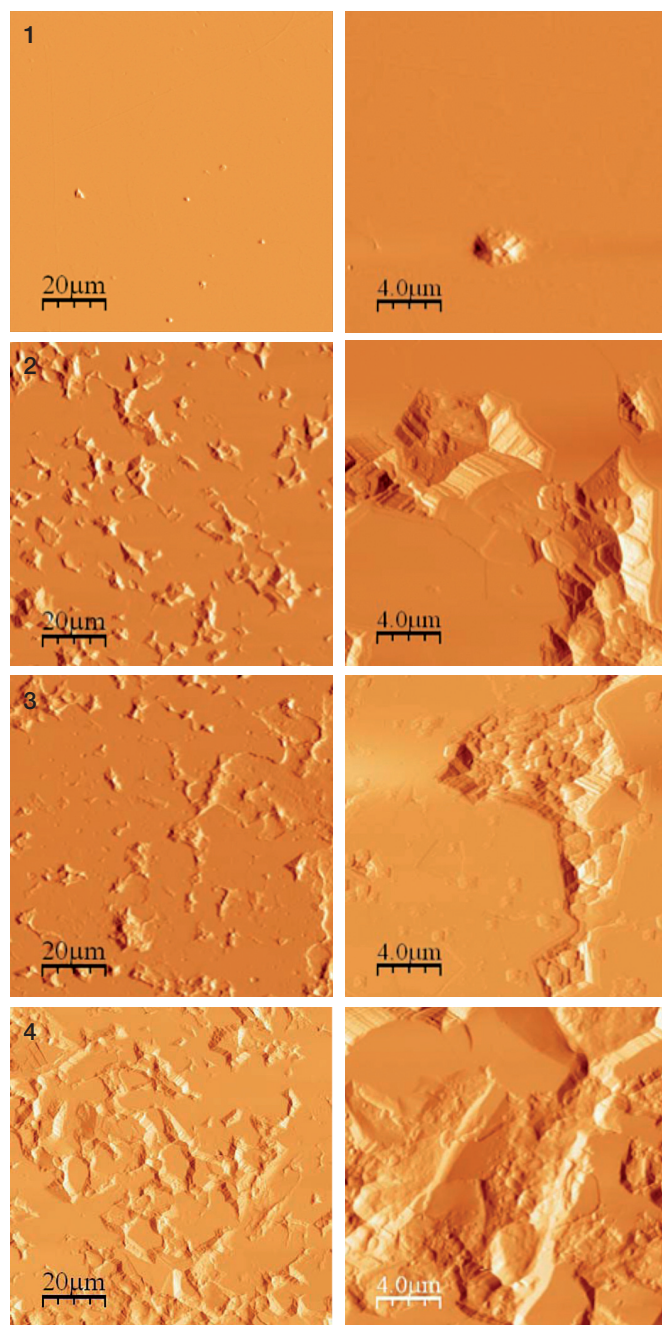
Six femoral heads (bearings MF, DD, JF, DAS, RL, and JL) were also imaged using the AFM. Images were taken of the smooth areas, darkened areas, rough areas, and areas with stripe wear. The increasing severity of wear on the bearings is illustrated in Figure 3.

These images showed that the smooth areas were flat and even, displaying just a few incidences of granular pullout resulting in fewer and smaller pits. The majority of these pits were $0.2\text{--}0.3 \mu\text{m}$ in depth and $2 \mu\text{m}$ wide. The darkened, roughened areas and the areas showing stripe wear showed higher peaks and valleys with more substantial granular pullout, and also some material deposition. In the roughened areas, the pits were up to $1 \mu\text{m}$ deep and $10 \mu\text{m}$ wide. Areas of stripe wear showed pits measuring $1 \mu\text{m}$ deep and $15 \mu\text{m}$ wide.

Figure 3. Atomic-force microscope images of smooth areas (1), darkened areas (2), roughened areas (3), and stripe-worn areas (4) of femoral heads, all at 2 magnifications.

The surface topographical and AFM observations of these first-generation bearings suggest that the wear process is a continuum with the initially smooth bearings experiencing granular pullout, to produce roughened areas.

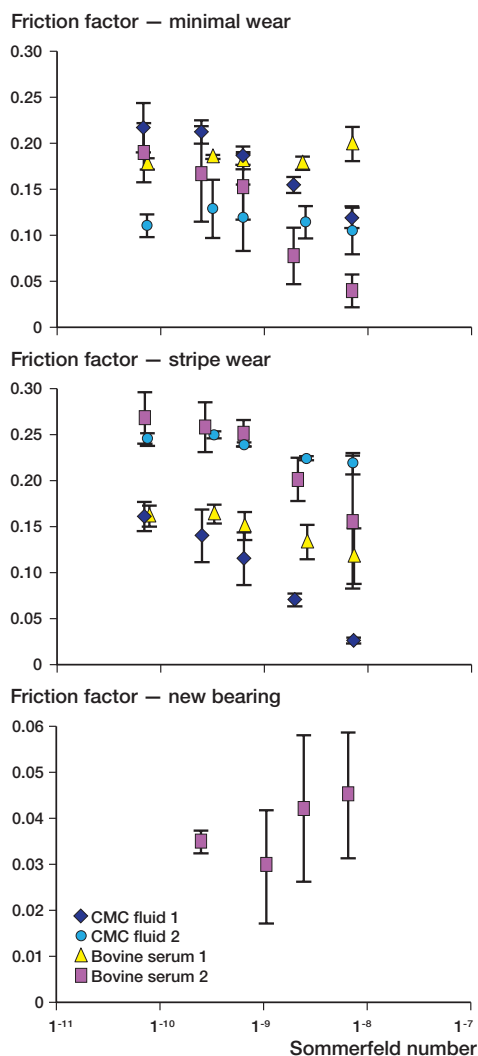
The lubrication regime was inferred from the Stribeck plots of bearing couples (Figure 3). The explanted joints tested operated in a mixed/boundary lubrication regime with a decreasing friction factor observed with increasing Sommerfeld number.

Figure 4. Stribeck plots of bearings with minimal wear and stripe wear, and of a newly manufactured bearing.

The damage apparent on the explanted joints created a far higher degree of friction, and these joints appeared to be working within mixed/boundary lubrication, resulting in considerable contact between the bearing surfaces. When bovine serum was used as the lubricant, it is likely that a protein layer formed on the bearing surfaces. When testing the joints as manufactured, Scholes and Unsworth (2006) discovered that this protein layer resulted in an increase in the friction factor developed because the protein adsorption disrupted the fluid film lubrication to give higher friction. In the current study, however, no fluid film lubrication was found, so this protein layer resulted in similar or lower friction since the shear stress of the proteins was lower than that of unlubricated ceramic. Thus, the damaged explanted joints produced similar or lower friction using bovine serum as the lubricant than when using CMC fluids, and this may have been due to protein-protein contact producing lower friction than ceramic-on-ceramic contact.

It appears that as the ceramic bearings get worn and roughened, the friction in the joint increases and mixed/boundary lubrication predominates. Synovial fluid would then play a more important role in reducing friction. It is difficult to tell how often CoC bearings exhibit fluid film lubrication in vivo, as although hip simulator studies have shown these joints to work close to full-fluid film lubrication during the standard gait cycle, this is only part of the daily activities that an artificial joint will encounter. Other activities such as stair climbing or rising from a sitting position are also common activities that have not been measured.
